SUBJECT: Solid Propellant Facilities REFERENCE: (a) Requirement C-DDI-3-80,555 (b) CIA/PID Project C 1270-63 1. This memorandum is a partial response to your requirement dated 9 September 1963 requesting detailed studies of the test facilities and associated plants at Biysk, Sterlitimak, and Perm (Kirov 98). 2. The attached photographs and line drawings are of the Biysk Test Facility. Due to poor quality photography a detailed study of the associated plant does not appear justifiable at this time. 3. The test facility can be negated in and scarring first and scarring first buildings 21-24 has been developed since have been color coded to show the dates when they were first discernible on photography. Annotations 2 and 3 are dark areas but cannot be identified as structures. 4. All measurements were derived from scales provided by TID/NPIC and are to be considered approximate. Height measurements have not been completed and will be forwarded at a later date. 5. The quality of photography does not permit an estimate of the type of construction nor the stage of construction of any structure. Functions of particular buildings or the bunkers/deflectors cannot be determined at this time.

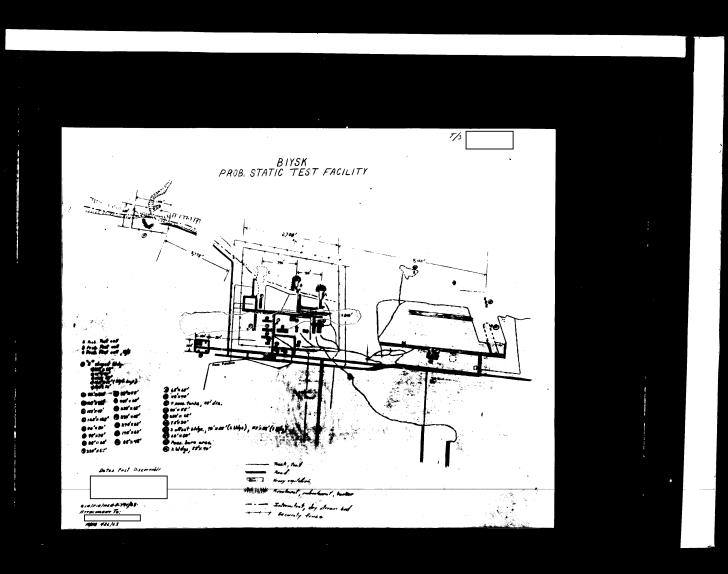
CIA/PIO/MEB-P-193/63 ATTACHMENT TO:

B- Probable Test Cell

83 - 80' × 30'
